**UNITED STATES ENVIRONMENTAL PROTECTION AGENCY
REGION IX**

Purpose: RCRA Compliance Evaluation Inspection
Facility: Survival Systems International

Location
Address: 34140 Valley Center Road
Valley Center, CA 92082

RCRA ID Number: CAD982508541
Date of Inspection: August 9, 2012
Time In/Time Out 9:00 a.m. -3.30 p.m.

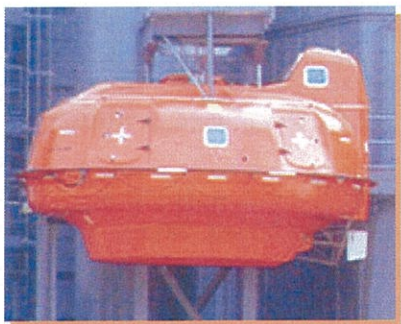
The capsule shell is manufactured buy spraying a gel coat onto a fiberglass laminate in a mold. Once the fiberglass has hardened, it is trimmed, separated from the mold and assembled. The engine, oxygen tanks, seats, ventilation system and all necessary equipment are installed in the bottom half of the shell prior to attaching the upper half of the shell. When the survival capsule/boat is finished, it is tested for structural integrity.

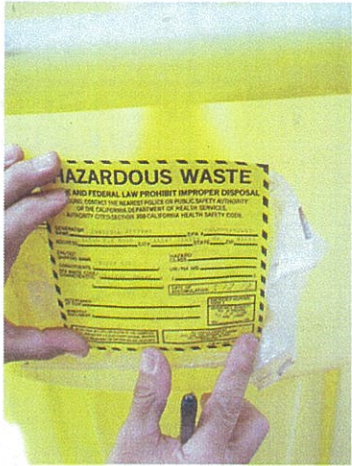
<p>Photo# 8090008</p>	<p>The words “Used Oil” were added to the label during the inspection.</p>
<p>2. SAA outside the Priming Booth Building: 30-gallon container holding paint debris noted open.</p>

Observation	Photograph	Comments
<p>1. SAA outside the Cable Testing Area: Poly drum SAA with 55-gallon container not labeled with the words “Used Oil.”</p>

NO.	STATUTE OR REGULATION	REGULATION SUMMARY	FINDING(s)	FACILITY RESPONSE
1	40 CFR § 262. 21 (f)(7)(i)(A)	<p><i>(7)The instructions in the appendix to 40 CFR part 262 must appear legibly on the back of the copies of the manifest and continuation sheet as provided in this paragraph (f).</i></p> <p><i>(i) Manifest Form 8700-22.</i></p> <p><i>(A) The "Instructions for Generators" on Copy 6;</i></p> <p><i>(1) Generator must enter EPA ID#</i></p>	<i>The facility was using a California Only HW ID number and not the EPA ID number as required by the instructions in the manifest.</i>	
2	40 CFR § 265.173(a)	<i>A container holding RCRA hazardous waste must always be kept closed, except when it is necessary to add or remove the waste.</i>	<i>One open 30-gallon container holding paint contaminated waste was observed in SAA outside the Priming Booth Building</i>	
3	40 CFR § 279.22(c)(1)	<i>Used oil generators are subject to(c) Labels. (1) Containers and aboveground tanks used to store used oil at generator facilities must be labeled or marked clearly with the words "Used Oil."</i>	<i>Poly drum with 55-gallon container was not labeled with the words "Used Oil," in the outside Cable Testing SAA.</i>	<i>The facility representative labeled the container with the words "Used Oil" during the inspection.</i>

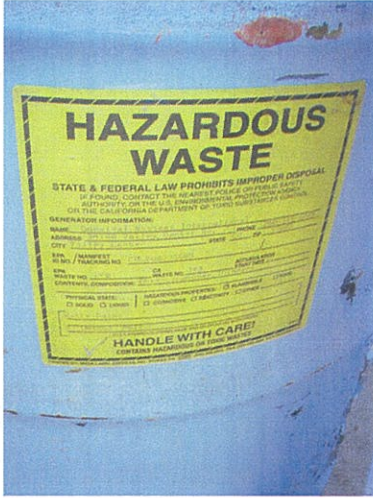
<p>Photo# 8090015</p>	The ASD was added to the label during the inspection.

Observation	Photograph	Comments
3. 55-gallon container holding waste paint, in the 180-day waste area, was not labeled with accumulation start date (ASD).

Comments: Inspectors noticed, two 55-gallon containers holding RCRA hazardous waste in the 180-day storage area, with a 6/29/2011 ASD. According to the facility representative, the containers had just been transferred to the storage area, and they were in the process relabeling them.

The containers were properly labeled with the information missing during the inspection.

NO.	STATUTE OR REGULATION	REGULATION SUMMARY	FINDING(s)	FACILITY RESPONSE
4	40 CFR §262.34(a)	<p>(a) Except as provided in subsections (c) and (d) of this section and section 66262.35, a generator may accumulate hazardous waste on-site for 90 days or less without a permit or grant of interim status, provided that:</p> <p>(2) The date upon which each period of accumulation begins is clearly marked and visible for inspection on each container.</p>	A 55-gallon container holding waste paint, in the 180-day storage area, was not labeled with accumulation start date (ASD).	The facility representative labeled the container during the inspection.
